## *Phase I Environmental Site Assessment*

**Phase I Environmental Site Assessment  
Wasilla Main Street Rehabilitation  
Wasilla, Alaska**

February 2012

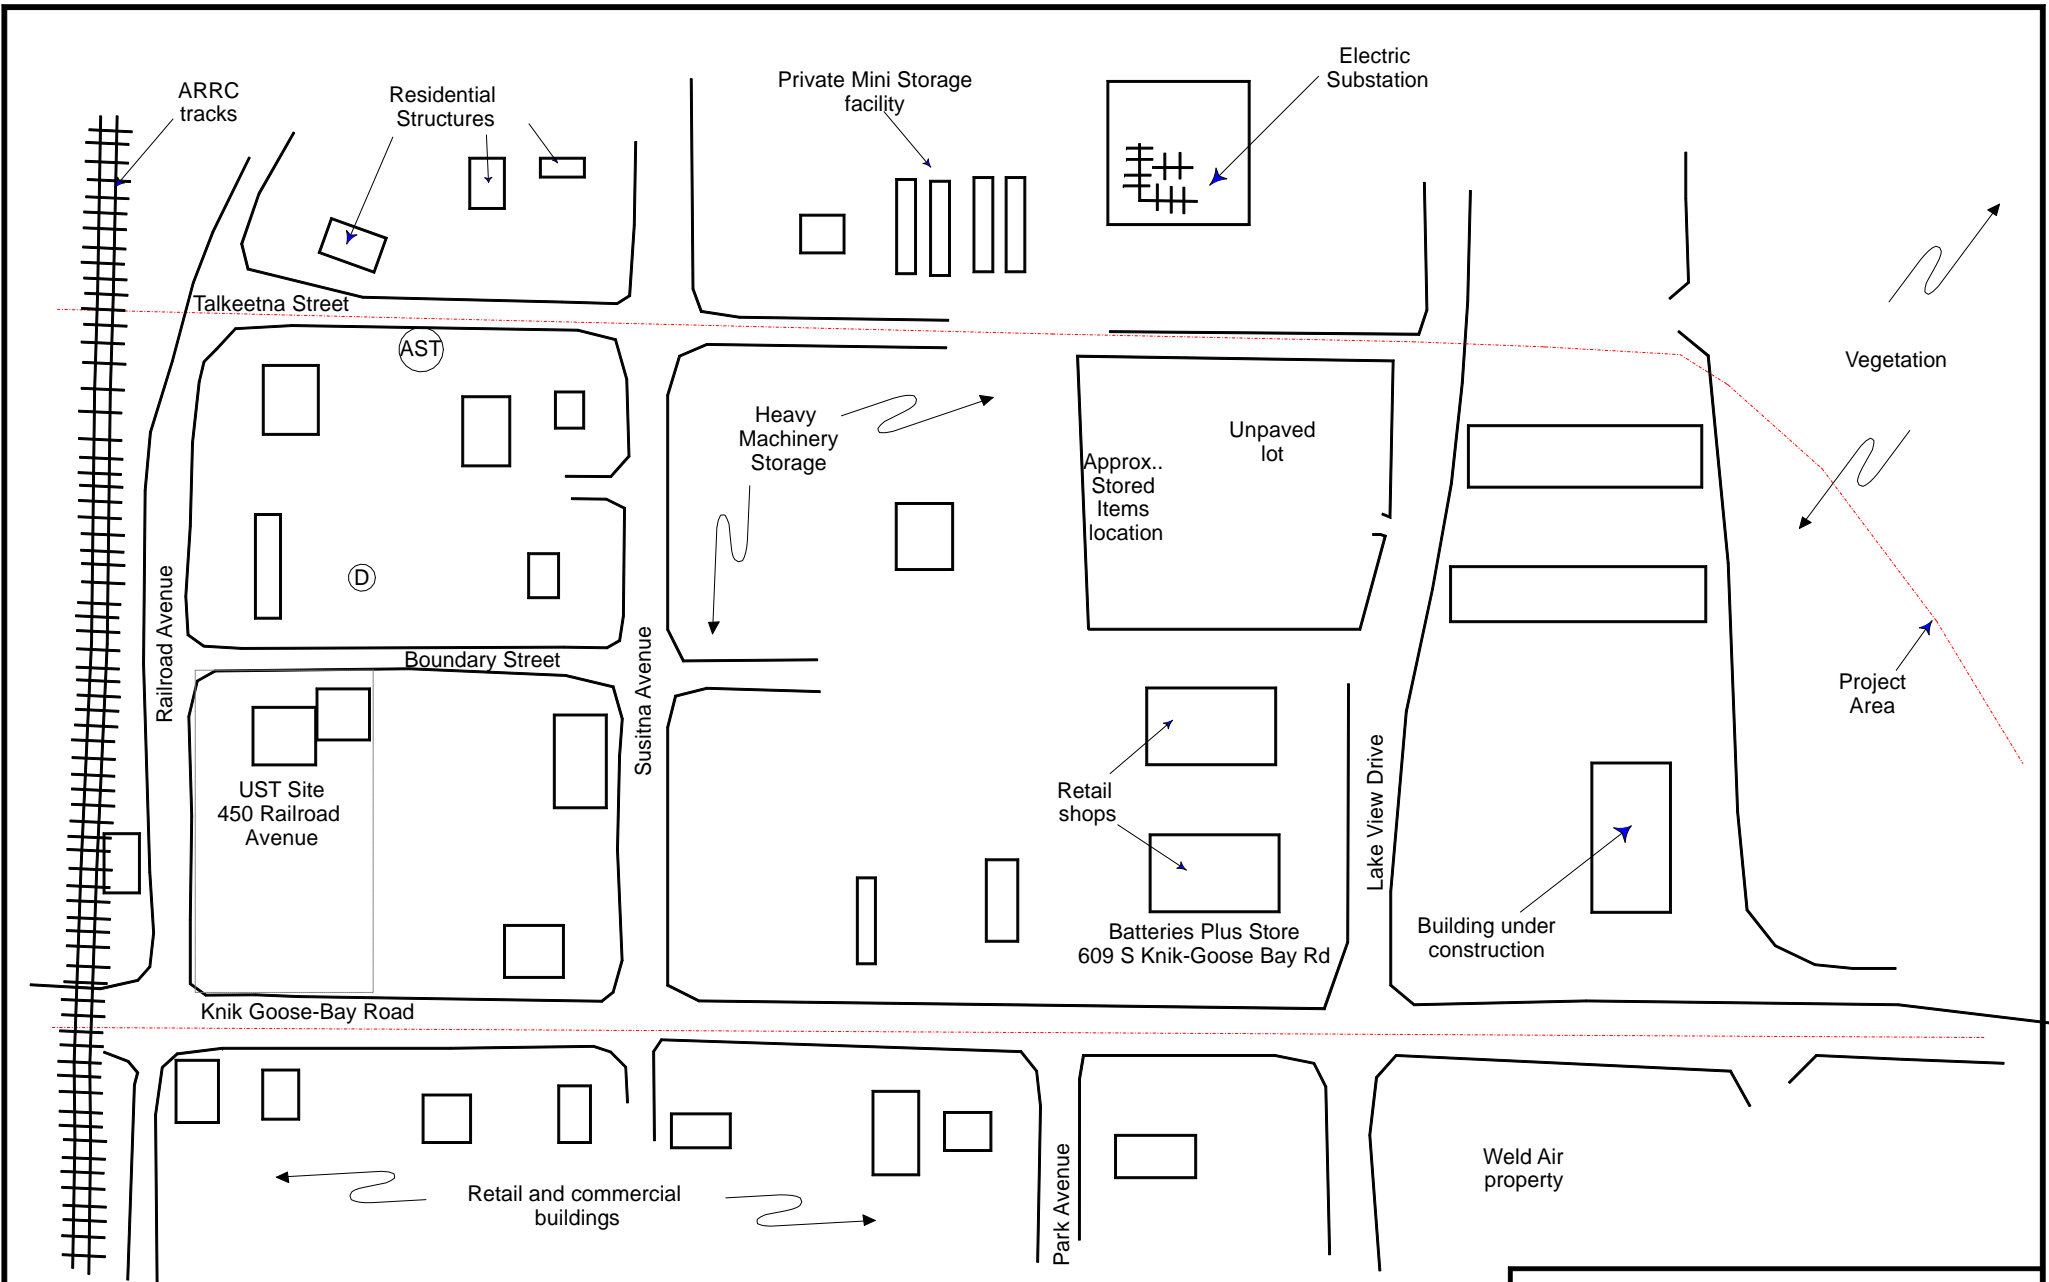
Wasilla Main Street Rehabilitation Wasilla, Alaska	
<b>INSERT MAP A</b>	
February 2012	32-1-17436
<b>SHANNON &amp; WILSON, INC.</b> Geotechnical & Environmental Consultants	
<b>Fig. 2</b>

Drums were not observed within the Project Area. A 55-gallon drum was observed in a storage lot on Boundary Street, approximately 200 feet west of the Talkeetna/Yenlo Corridor. The approximate location of this drum is shown on Figure 2.

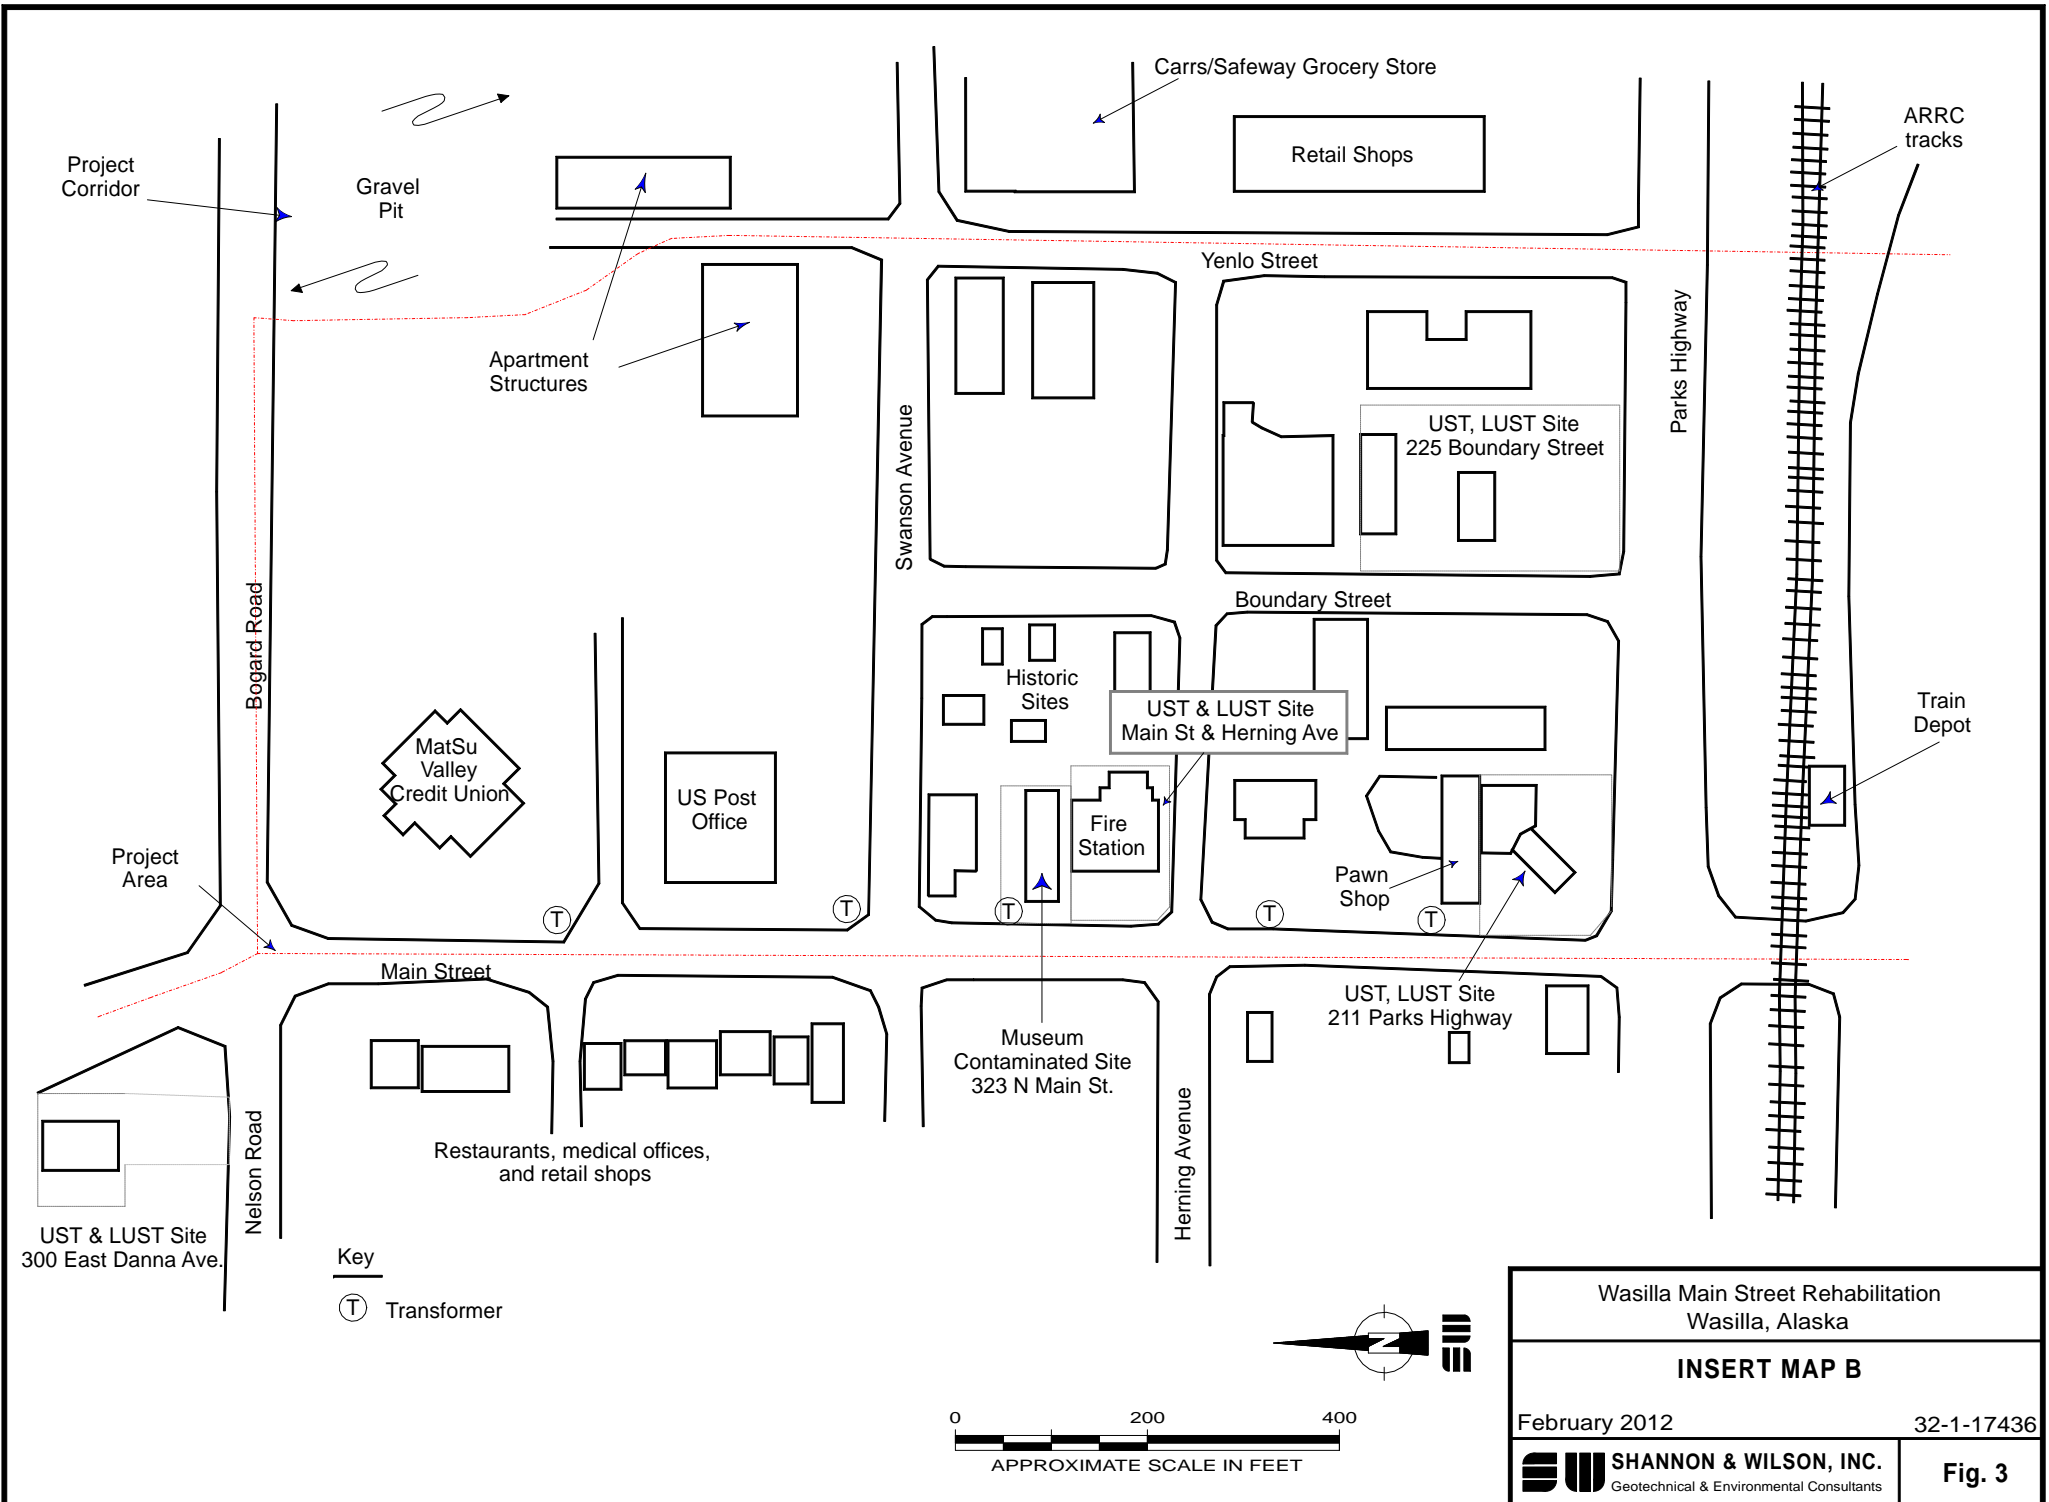
<b>SHANNON &amp; WILSON, INC.</b> Geotechnical & Environmental Consultants	<b>Fig. 3</b>

Five pole-mounted transformers were observed along the Main Street Corridor as shown in Figure 3. There were stickers from Matanuska Electric Association (MEA) indicating that the transformers did not contain PCBs.

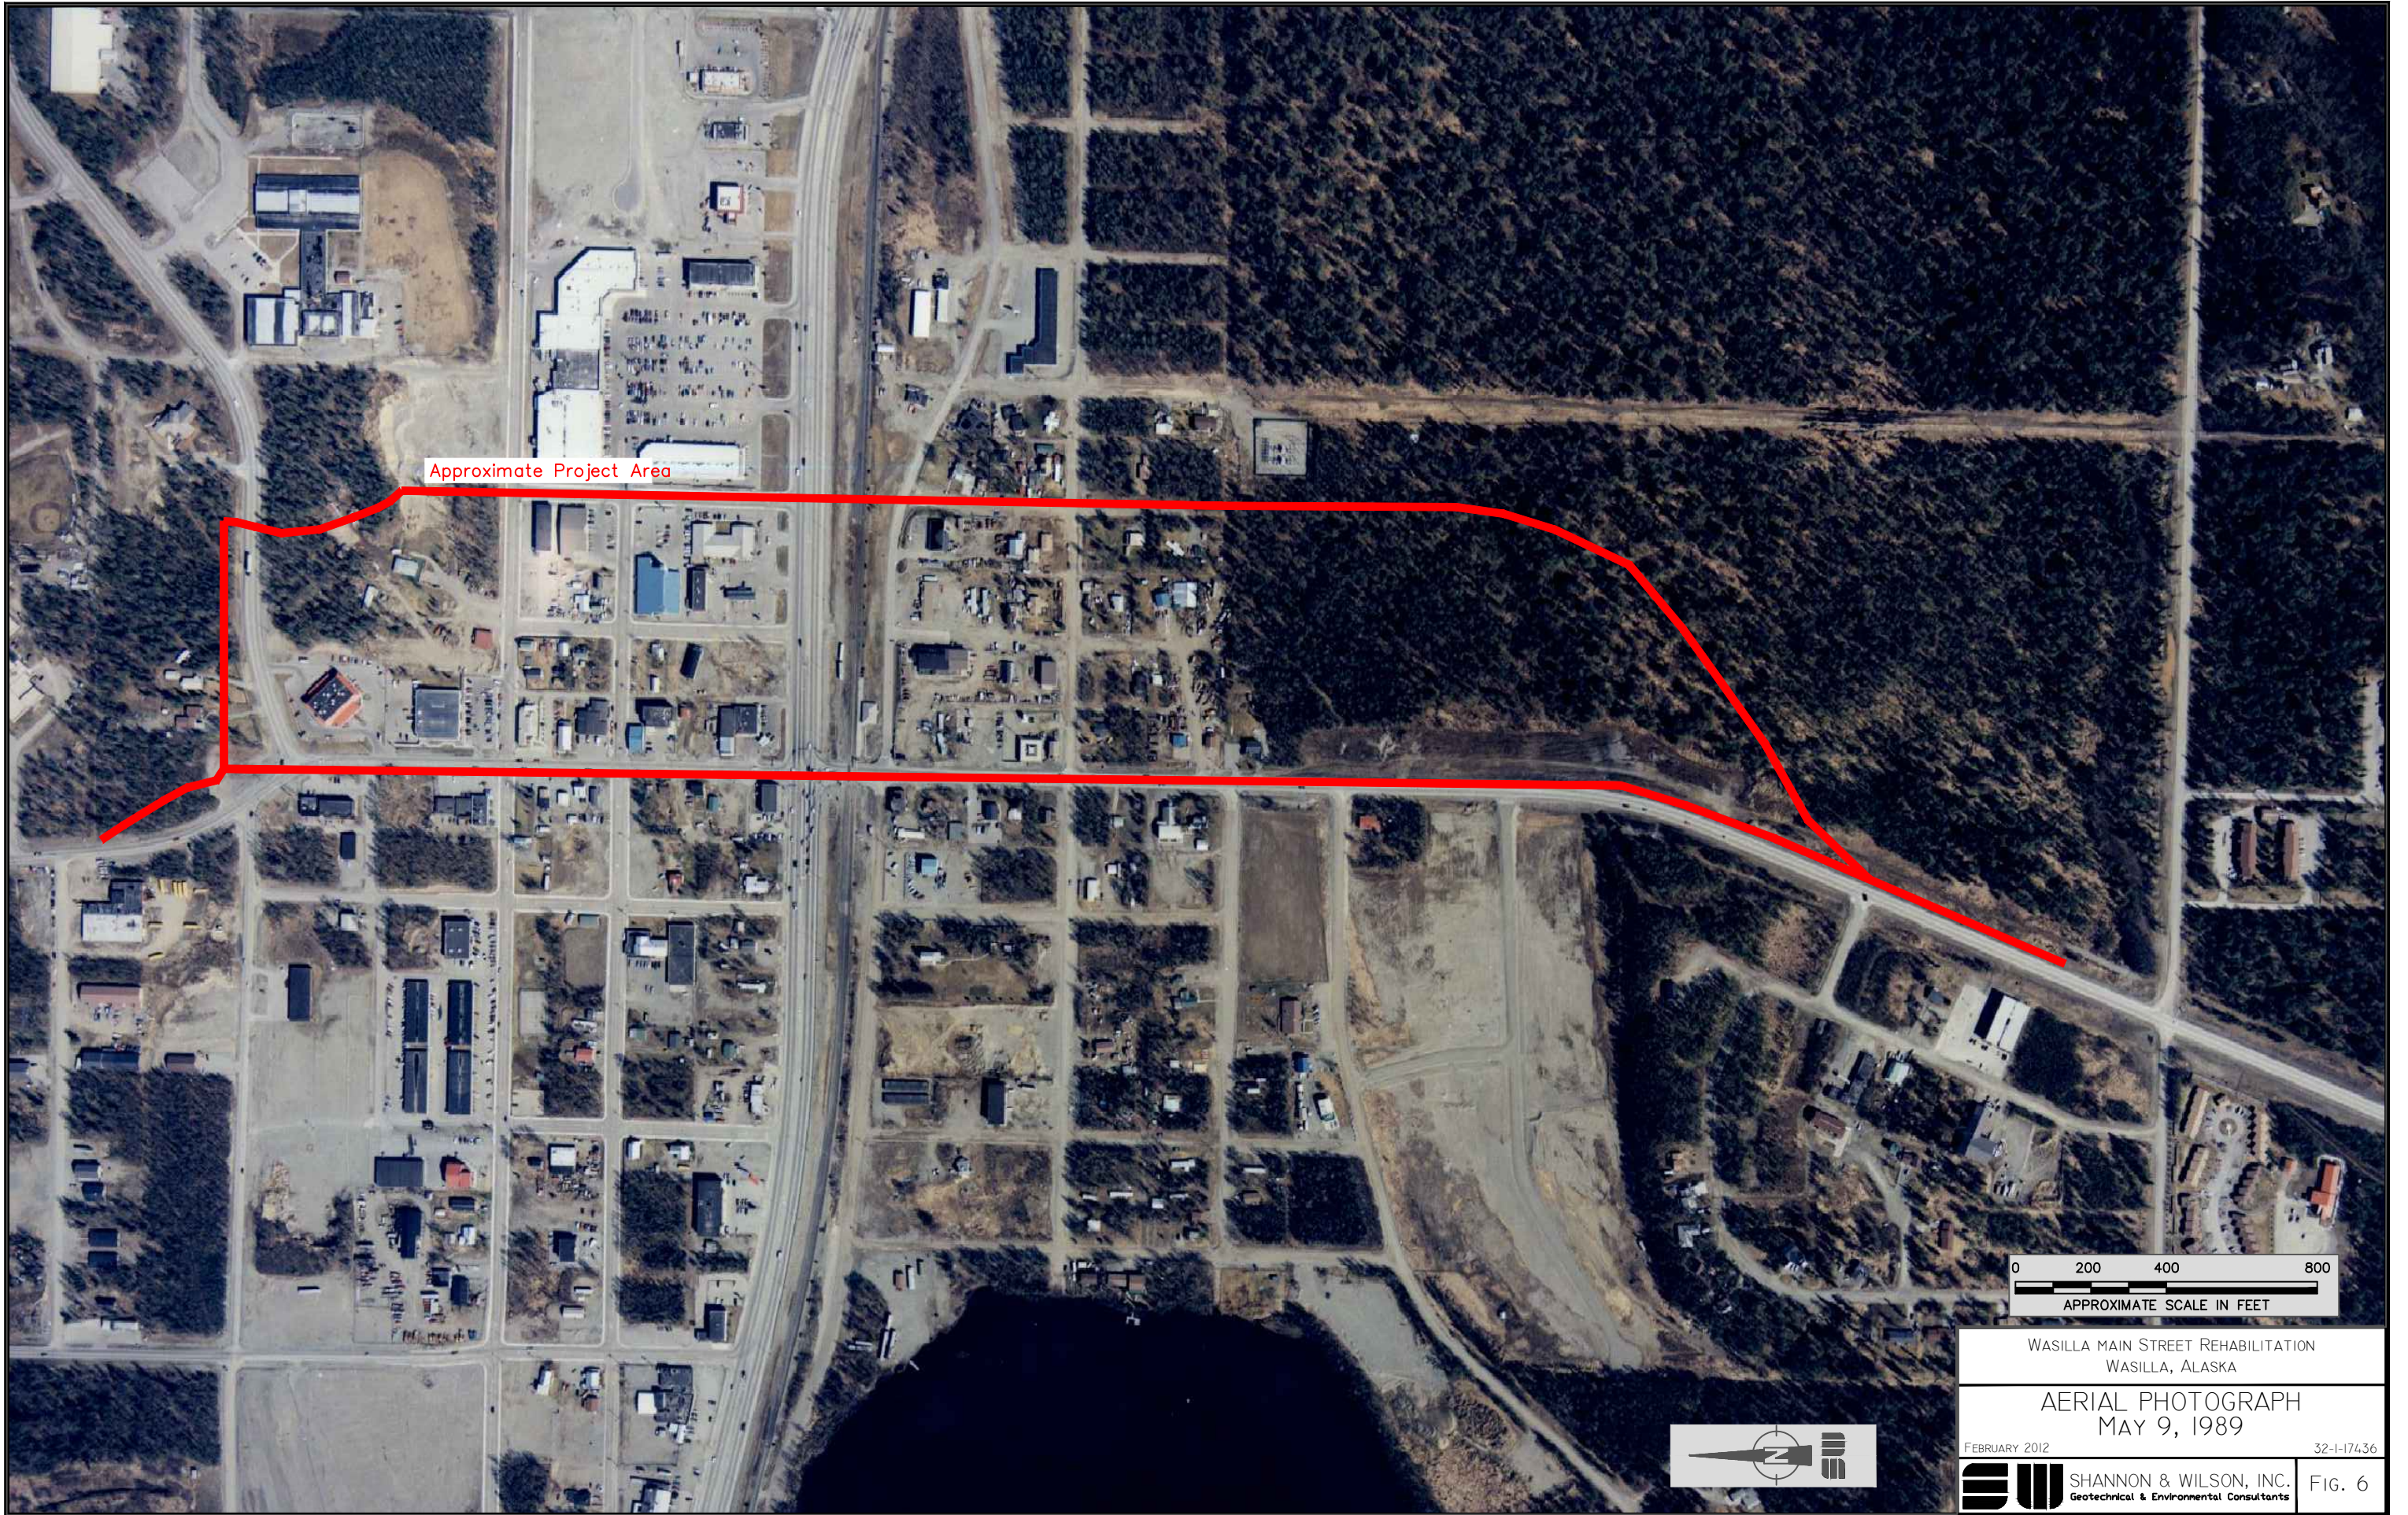
FIG. 6

The May 9, 1989 photograph is included as Figure 6. Commercial structures have been constructed along the northern portion of Main Street. Two filling stations have replaced former structures located at the Main Street and Parks Highway intersection and the Boundary Street and Parks Highway intersection. The Parks Highway has been widened to a four-lane road. Larger structures have replaced structures to the east and west of Main Street. Increased vehicle storage is present along KGB Road and Talkeetna Street. Parcels have been cleared, and structures have been built along the southern portion of KGB Road.

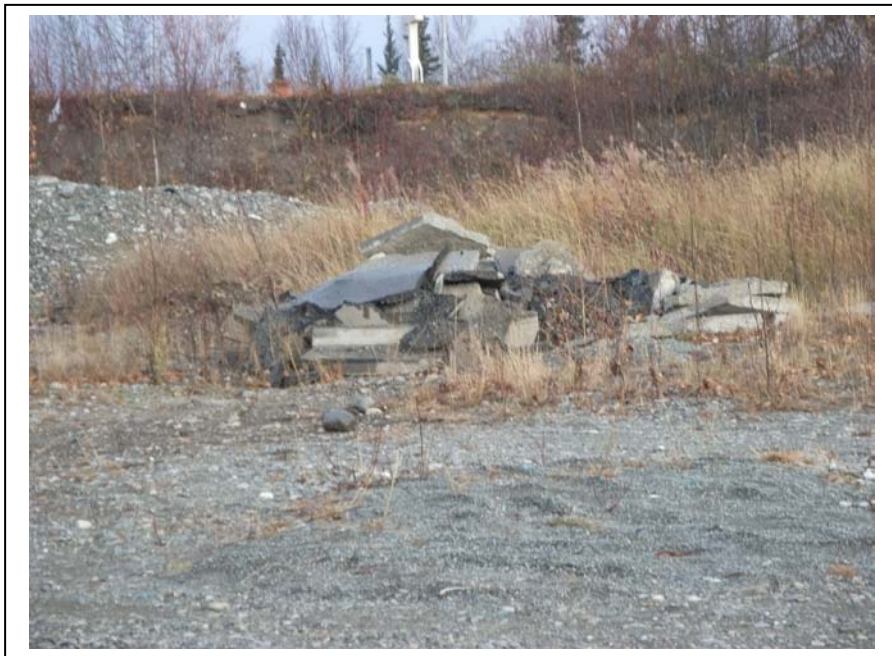
Based on our visual observations, records review, and interviews, the Project Area was not used for disposal of construction debris, demolition debris, or other solid waste. Concrete and asphalt debris were observed along the Yenlo Street ROW.

Photo 6: Concrete and asphalt debris located in the northern portion of the Yenlo Street ROW. (October 18, 2011)

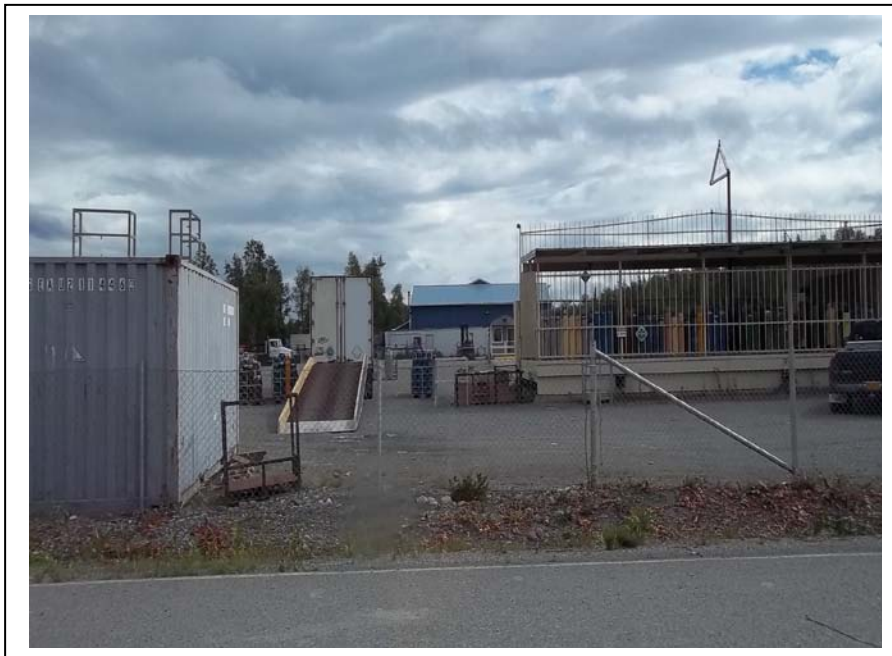
Weld Air is located adjacent west of KGB Road, along Centaur Avenue (Photo 7). Pressurized gas canisters were observed in the Weld Air Storage Lot (Photo 8). Commercial, retail, and residential structures are located along KGB Road, including a carwash, equipment rental shop, and a church. The train depot is located southeast of the KGB Road and Parks Highway intersection (Photo 9). A Tesoro filling station is located northeast of the Main Street and Parks Highway intersection (Photo 10). A pawn shop is located adjacent north of the filling station (Photo 11). Multiple vehicles and snow machines were observed in the pawn shop's storage lot

Photo 8: Compressed air canisters observed on the Weld Air property. (August 3, 2011)

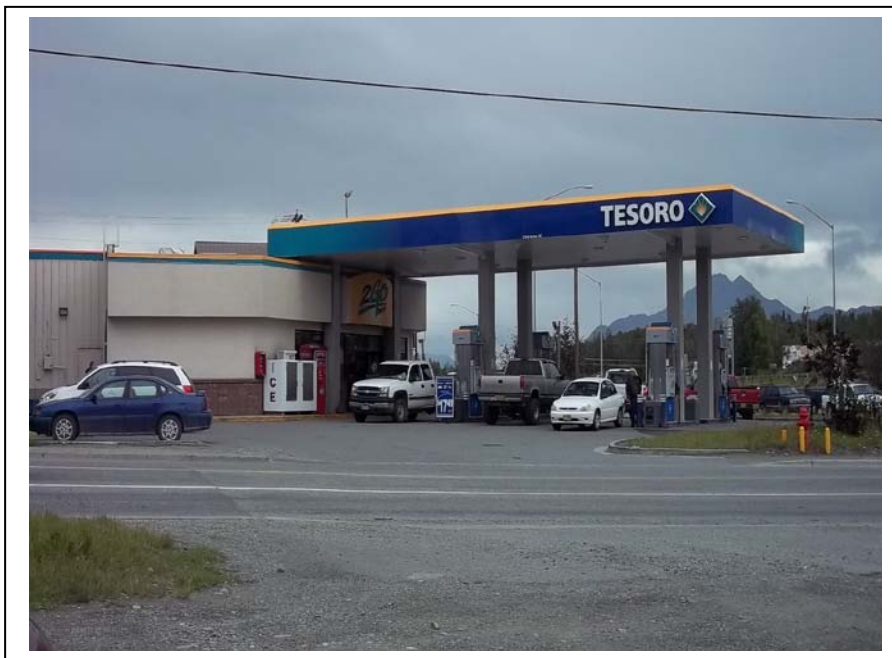
While there are no “active” LUST sites or “open” contaminated sites adjacent to the Project Area, it is noted there are two active filling stations within 90 feet. A Tesoro filling station is located adjacent to Main Street at 211 N Main Street. A Holiday filling station is located 90 feet west of Yenlo Street, at 225 N Boundary Street. These sites constitute a REC because of documented past releases of petroleum hydrocarbons and because they pose a material threat of a release of petroleum hydrocarbons that could impact the environment. It is important to note that ASTM allows the identification of a REC for a site that is in compliance with applicable laws.

Photo 10: The Tesoro filling station located adjacent to Main Street and the Parks Highway. (August 3, 2011)

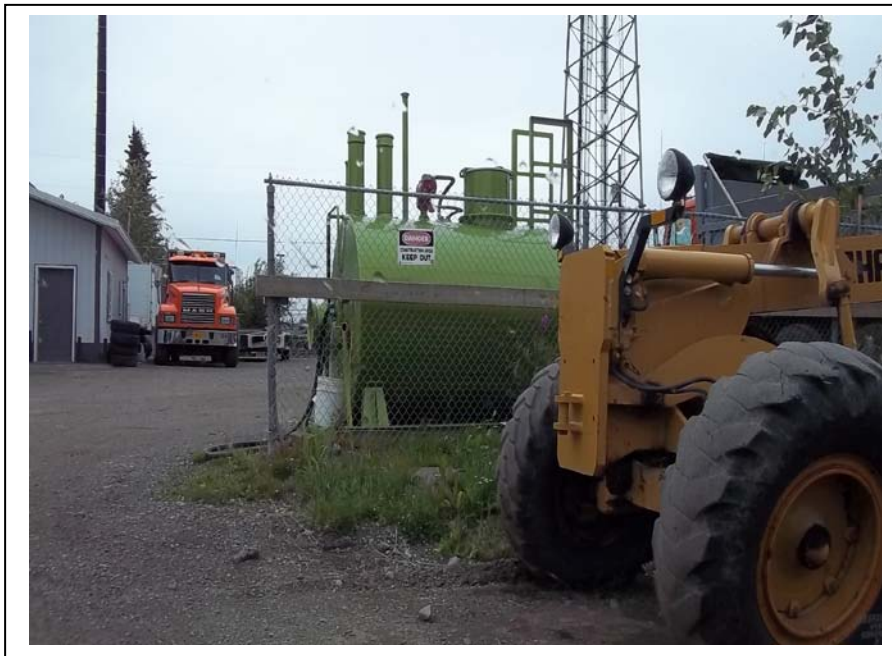
Photo 18: The above ground storage tank located on Talkeetna Street. (August 3, 2011)
