## *Phase I Environmental Site Assessment*

**Phase I Environmental Site Assessment  
Wasilla Main Street Rehabilitation  
Wasilla, Alaska**

February 2012

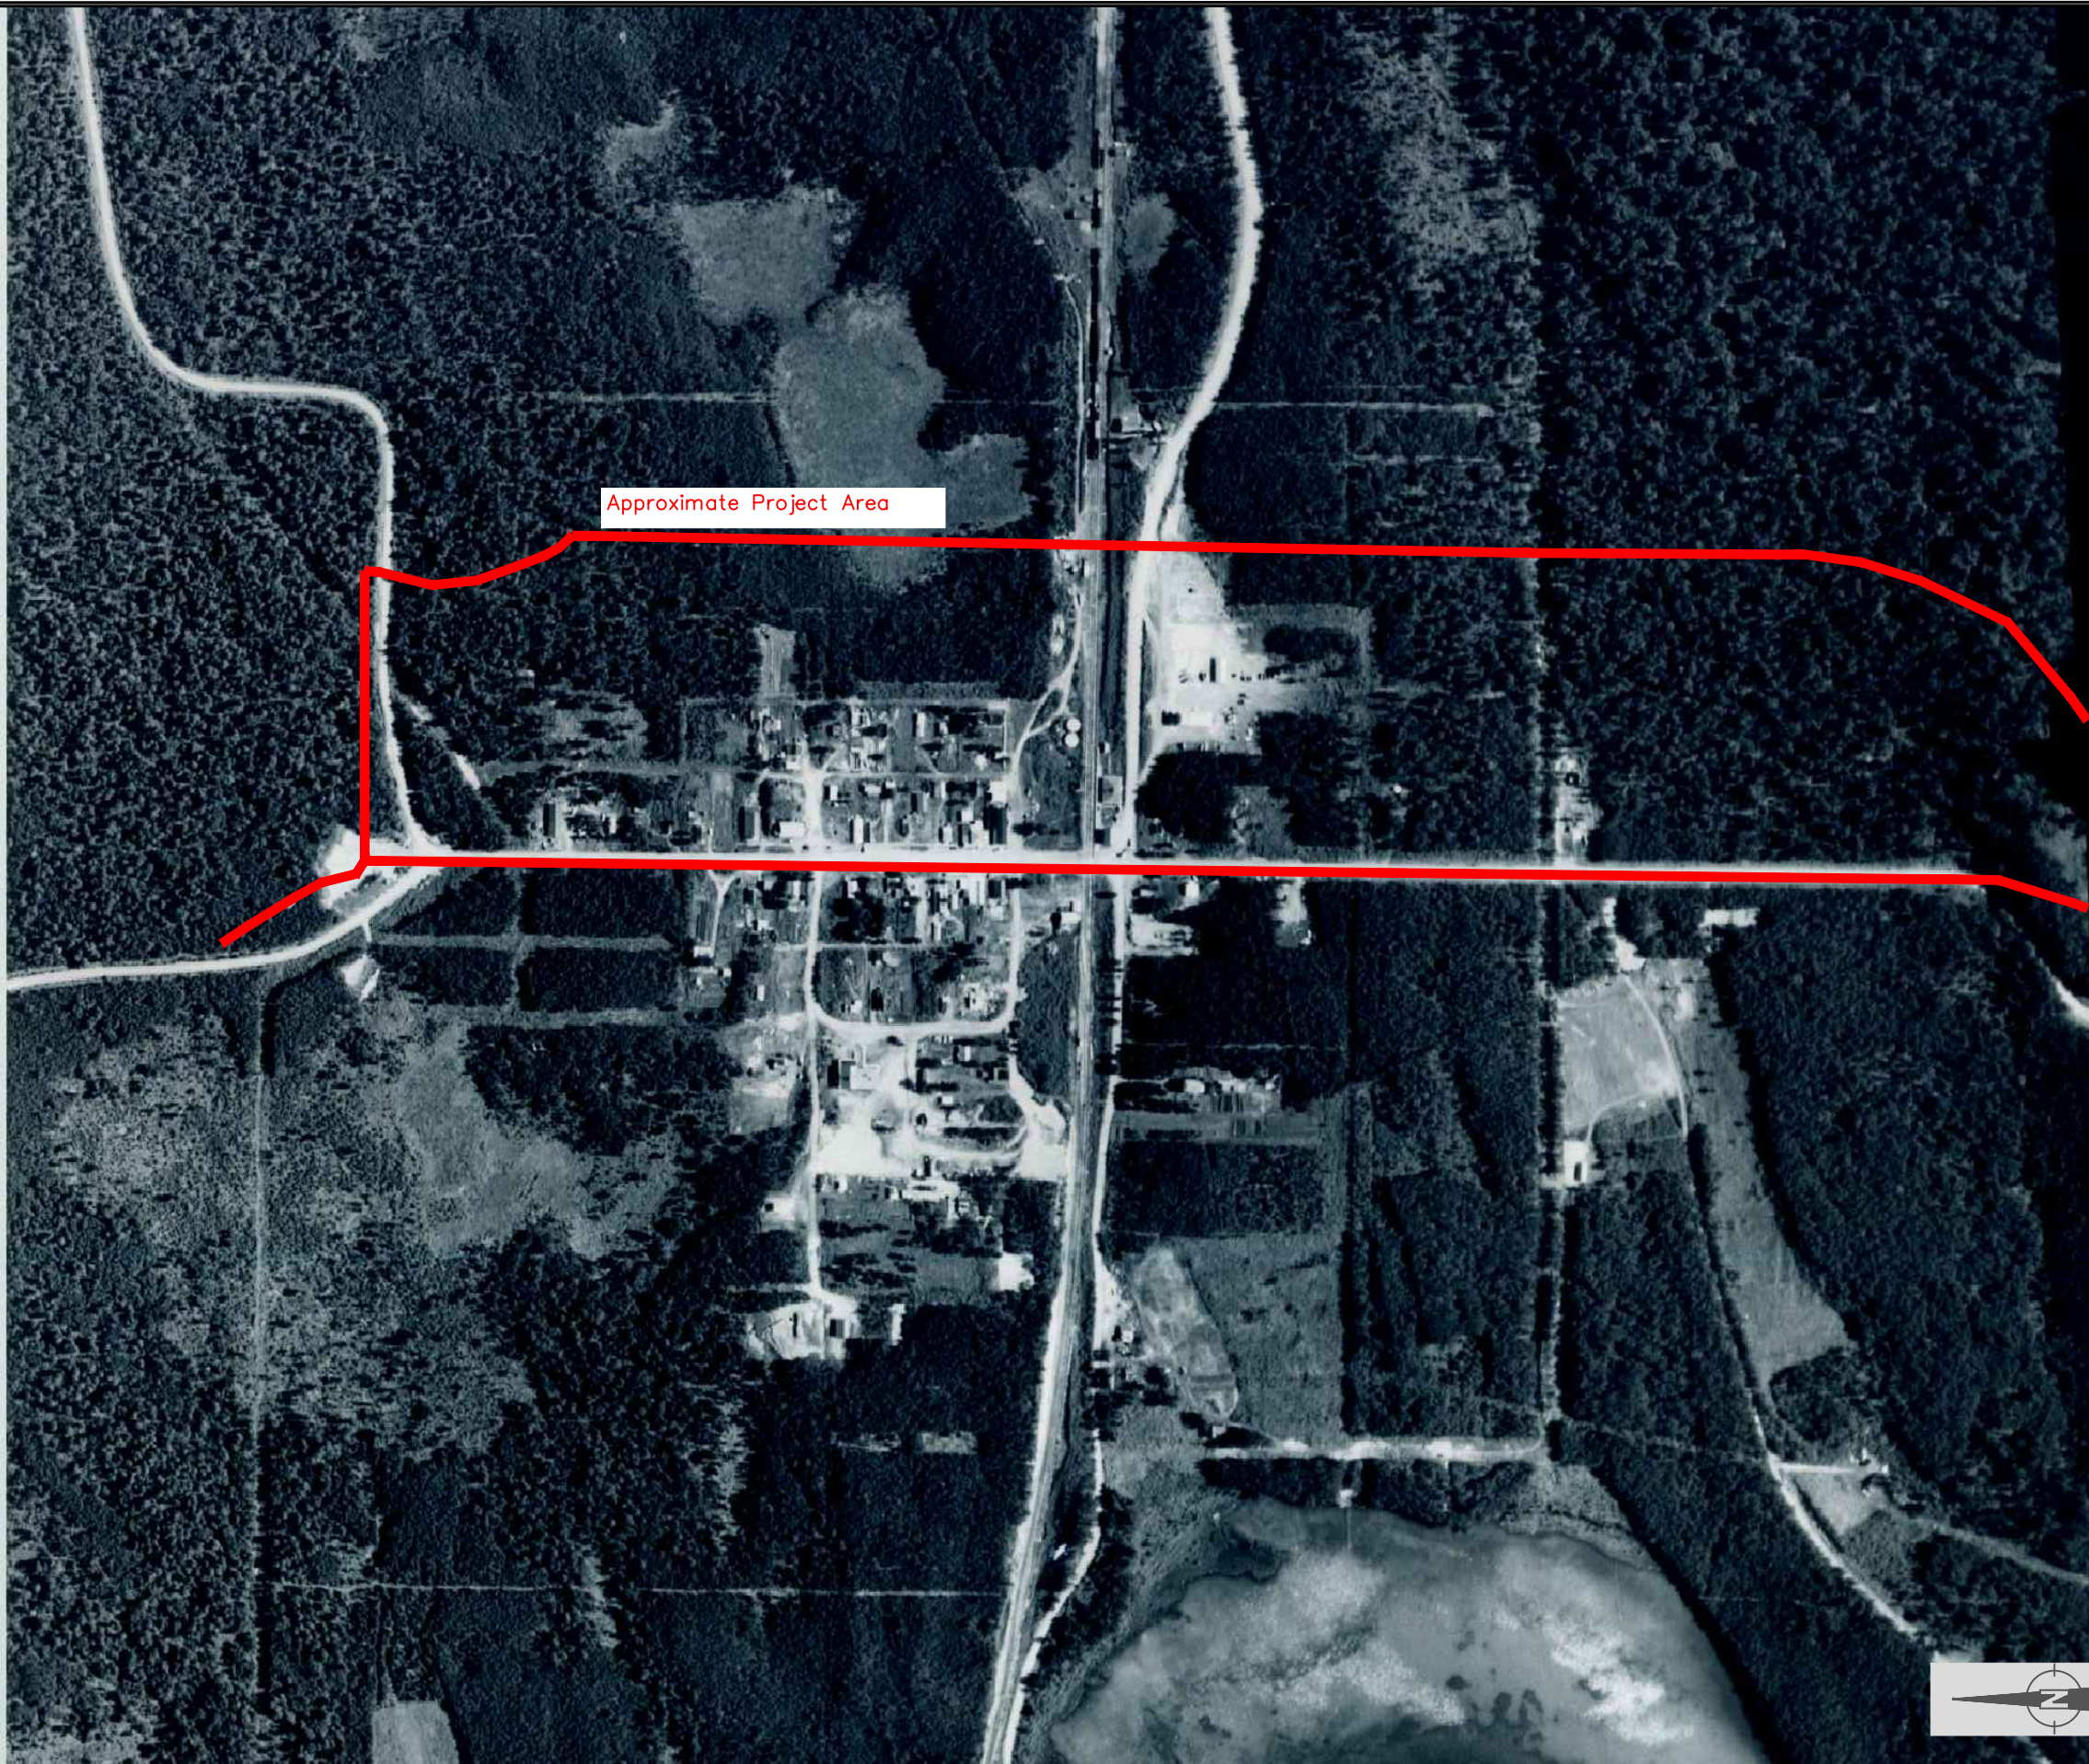
FIG. 4

Surface stains were observed on Talkeetna Street, located within the Project Area. This staining was observed during the aerial photograph review, most notably in the 2011 aerial photograph. Precipitation prior to the site visit limited observation of the staining while in the field; however, areas of darker soil were observed. The areas observed during the site visit included the soil in the vicinity of 450 Talkeetna Street, where heavy machinery was stored, and the portion of Talkeetna Street between East Railroad Avenue and East Susitna Avenue. The impact or source of released contaminants to the subsurface is unknown. Although ASTM 1527-05 contains allowances for 'de-minimis' conditions; Alaska regulations concerning the release of oil or hazardous substances do not recognize 'de-minimis' conditions and also require cleanup of surface stained soil. Therefore, because the surface staining would likely result in an enforcement action, it is defined as a REC by ASTM 1527-05. There are currently no other on-site RECs identified for the Project Area.

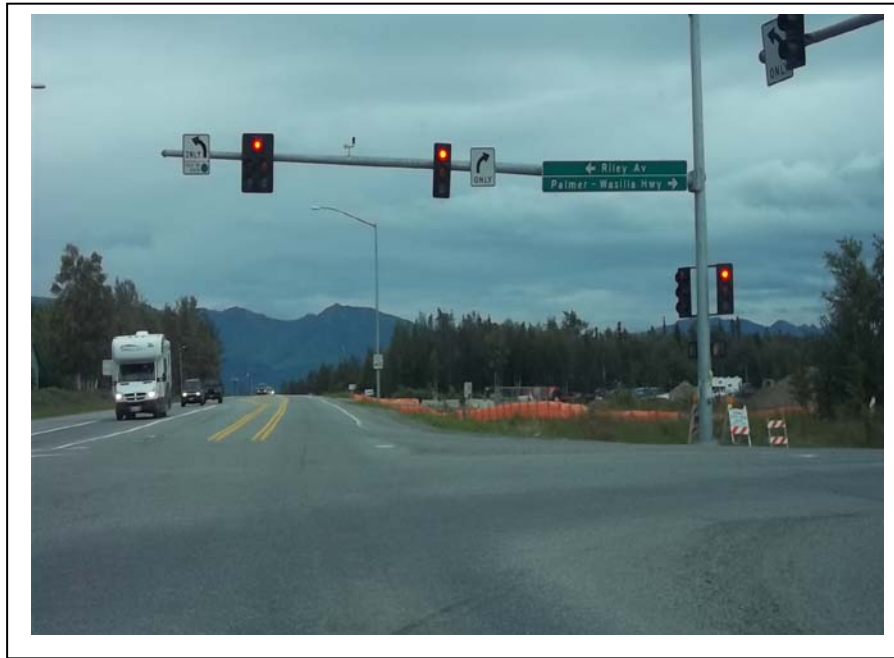
The KGB/Main Street Corridor includes a portion of KGB Road, which is a paved two lane road that begins approximately 350 feet north of Palmer-Wasilla Highway (Photo 1) and ends at the ARRC tracks. Bike paths run parallel to the roadway. The corridor continues north across the ARRC tracks and the Parks Highway onto Main Street, a paved three lane road that ends on Wasilla-Fishhook Road, approximately 250 feet north of the Bogard Road intersection (Photo 2).

Photo 1: The intersection of KGB Road and Palmer-Wasilla Highway. (August 3, 2011)

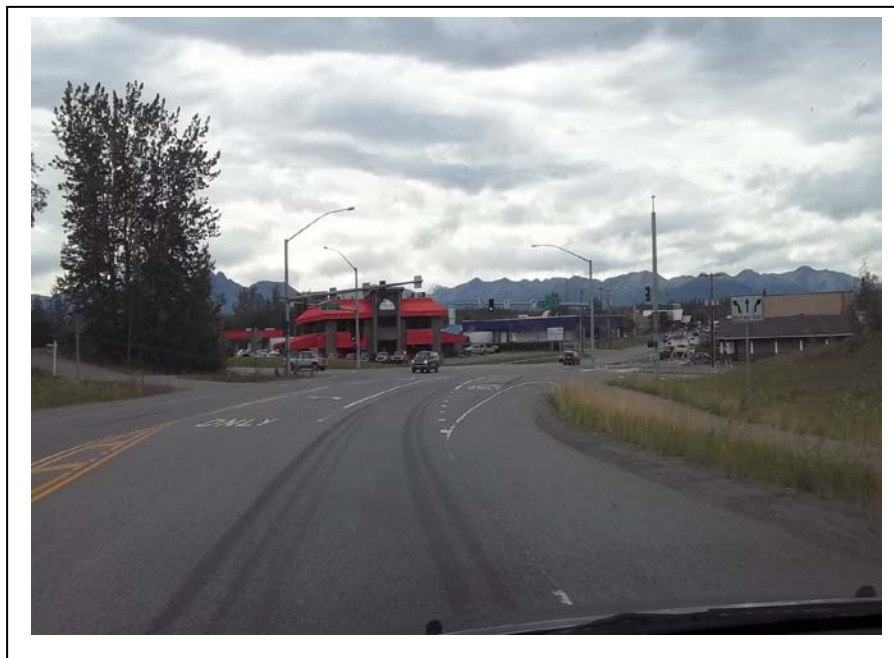
Photo 2: North of the Main Street and Bogard Road intersection, looking south. (August 3, 2011)

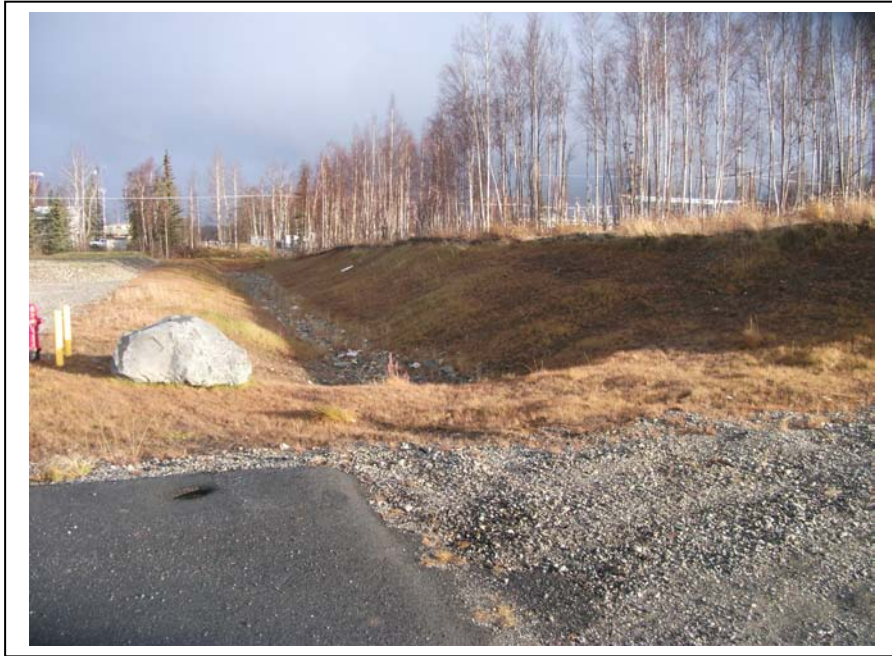
The Talkeetna/Yenlo Corridor begins at KGB Road and continues northeast through a cleared parcel onto an undeveloped, forested parcel until it intersects what would be the extension of the Talkeetna Street ROW. The southern portion of the Talkeetna Street ROW extension is a drainage ditch, (Photo 3). The corridor continues north along Talkeetna Street, which is an unpaved two lane road. It has rained just prior to the site visit and the unpaved roadways were still wet/damp from the rain. There appeared to be darker soil in the vicinity of 450 Talkeetna Street, where heavy machinery was stored. The portion of Talkeetna Street between East Railroad Avenue and East Susitna Avenue appeared to be darker than the portion of Talkeetna Street south of East Susitna Avenue. This could be due to historical dust suppression efforts or releases; however the source of the staining was not identified.

Photo 3: Drainage ditch located in the would-be extended Talkeetna Street ROW. (October 18, 2011)

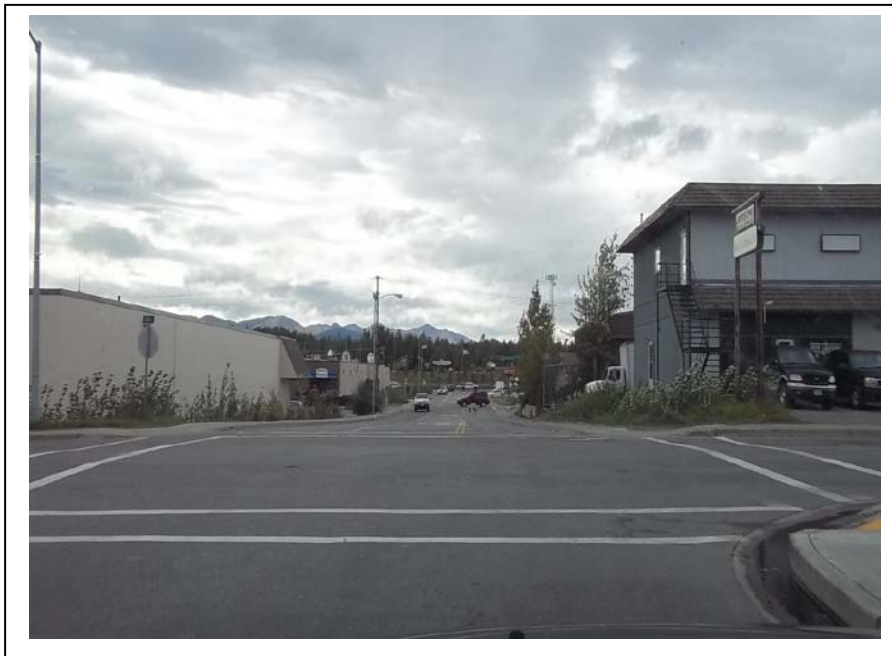
The corridor continues north, across the ARRC tracks and the Parks Highway onto Yenlo Street, which is a paved two-lane road, (Photo 4). Approximately 400 feet south of Bogard Road, Yenlo Street becomes unpaved and is no longer an established roadway. Gravel piles with some vegetation and concrete and asphalt debris were observed in this location (Photos 5 and 6). The corridor continues 90 degrees to the west along Bogard Road, a paved two-lane road, until it ends at the Main Street intersection.

Photo 4: Yenlo Street, at Swanson Avenue intersection looking south. (August 3, 2011)

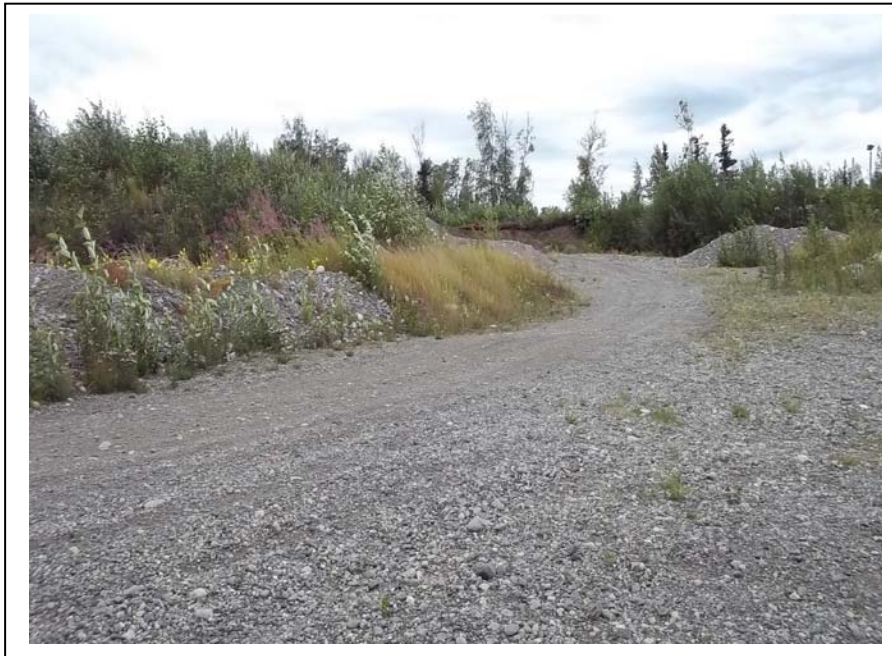
Photo 5: Gravel material and vegetation located on the northern portion of the Yenlo Street ROW. (August 3, 2011)

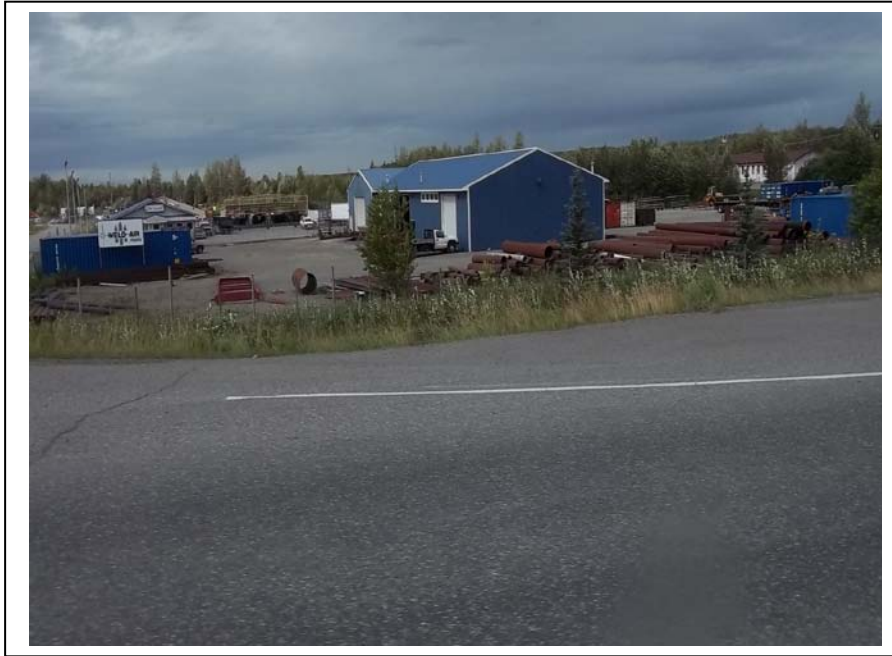
Weld Air is located adjacent west of KGB Road, along Centaur Avenue (Photo 7). Pressurized gas canisters were observed in the Weld Air Storage Lot (Photo 8). Commercial, retail, and residential structures are located along KGB Road, including a carwash, equipment rental shop, and a church. The train depot is located southeast of the KGB Road and Parks Highway intersection (Photo 9). A Tesoro filling station is located northeast of the Main Street and Parks Highway intersection (Photo 10). A pawn shop is located adjacent north of the filling station (Photo 11). Multiple vehicles and snow machines were observed in the pawn shop's storage lot

Photo 7: The Weld Air facility located adjacent west of KGB Road. (August 3, 2011)

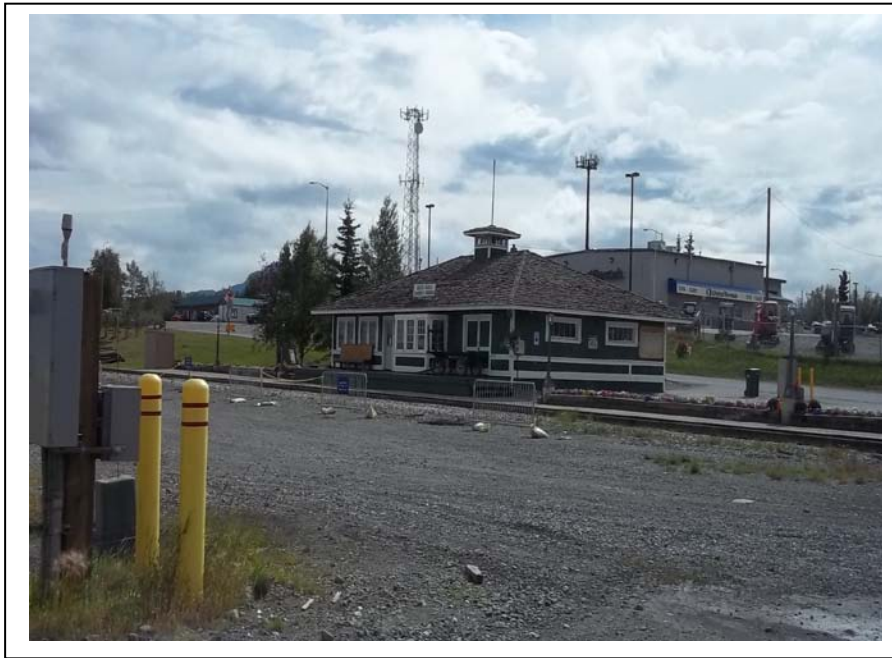
Photo 9: The train depot, located adjacent east of the KGB/Main Street Corridor. (August 3, 2011)

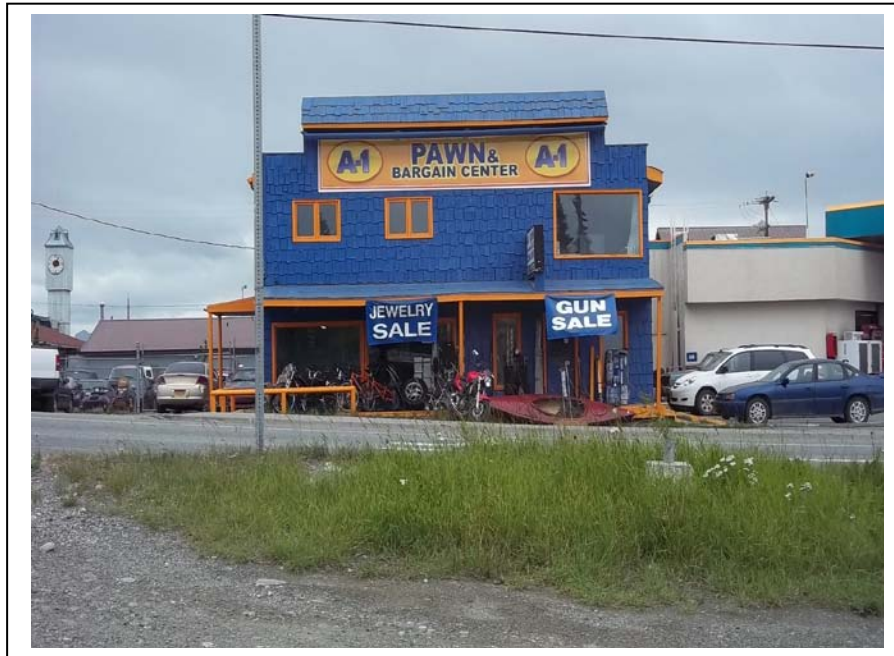
Photo 11: The pawn shop located along Main Street, adjacent north of the Tesoro filling station. (August 3, 2011)

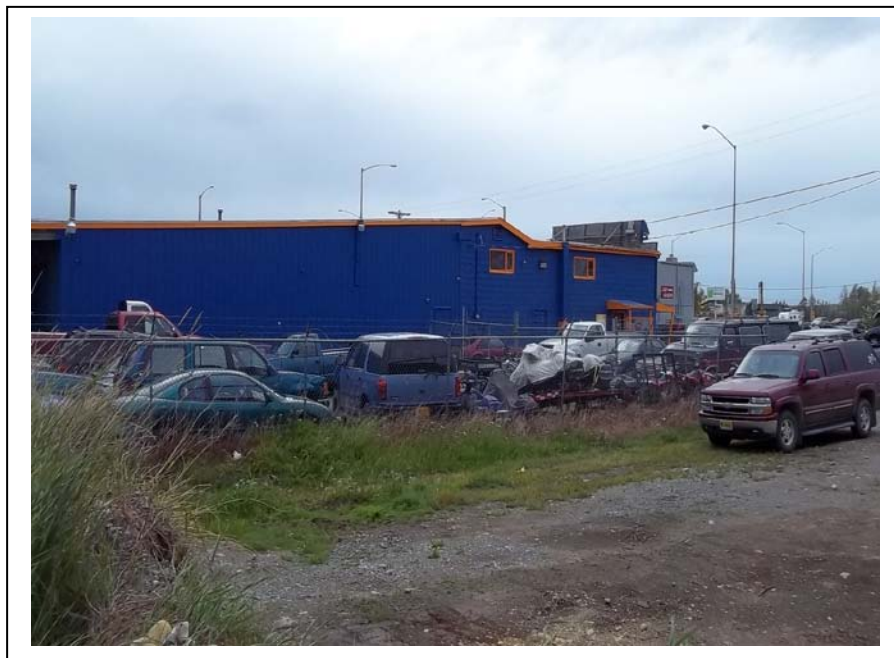
(Photo 12). Commercial structures, restaurants, the Mat-Su Valley Credit Union, the Wasilla City Library, a US Post Office, pawn shop, a fire station, and retail shops are located on parcels adjacent to Main Street. A residential structure is located east of Wasilla-Fishhook Road.

Photo 12: Vehicle and snow machine storage at the pawn shop on Main Street. (August 3, 2011)

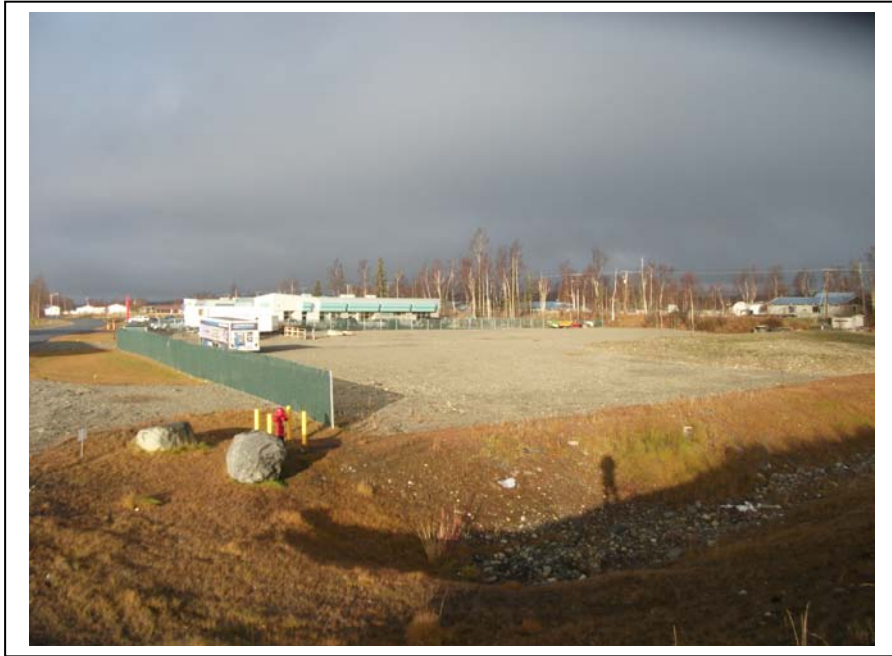
The corridor begins at KGB Road and heads northeast onto a cleared parcel, and continues onto undeveloped, forested land. Power lines run parallel to the corridor to the east as it follows a drainage ditch along the would-be Talkeetna ROW extension. An unpaved, fenced-in storage lot (Photo 13) and shopping center are located west of the Project Area. An electric substation is located adjacent east of the Talkeetna/Yenlo Corridor, (Photo 14). A mini-storage lot is located at the end of the Talkeetna Street ROW is also located in this area (Photo 15). Residential structures are located east and west of Talkeetna Street and south of Susitna Avenue. A restaurant, residential structures, and heavy machinery yard and operations building are located adjacent to Talkeetna Street (Photo 16). Tractors, a backhoe, dump trucks, vehicles, a boat, multiple storage annexes and an above ground storage tank were observed on the Talkeetna Street parcel (Photos 17 & 18). The corridor continues across Parks Highway onto Yenlo Street. Medical offices, retail shops, restaurants, and an insurance company are located west of Yenlo Street. A Carrs/Safeway grocery store and strip mall are located east of Yenlo Street. The Yenlo Apartments are located north of Swanson Avenue, along Yenlo Street. The most northern portion of the Talkeetna/Yenlo Corridor is partially vegetated with piles of gravel material. A church, residential structure and bank are located adjacent to this portion of the Project Area.

Photo 13: Unpaved storage lot located west of the would-be extension of the Talkeetna Street ROW. (October 18, 2011)

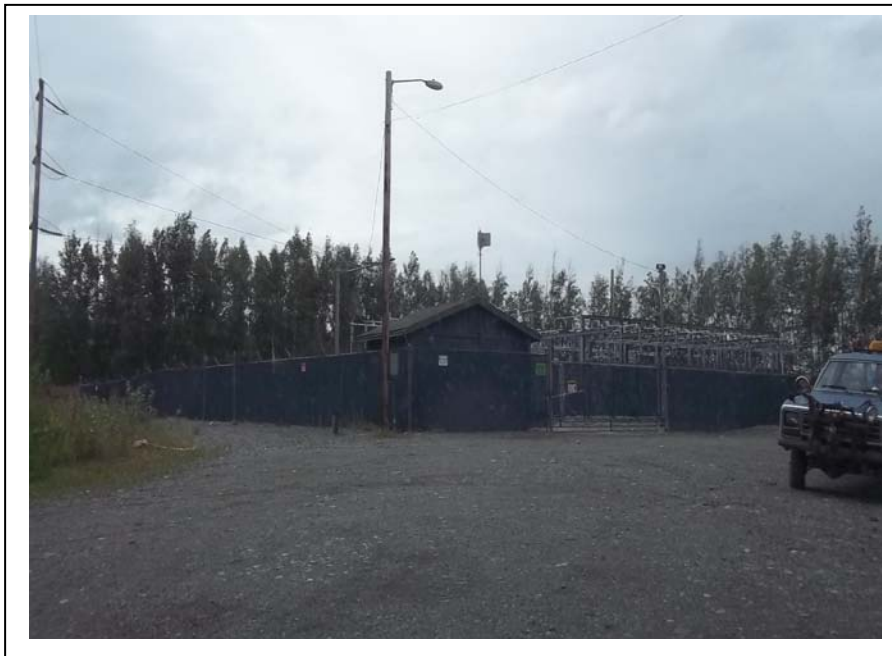
**High Voltage Power Lines.** During the site visit, potentially high-voltage power lines were observed running north-south approximately 200 east of the Talkeetna/Yenlo Corridor. These power lines run to and from a MEA substation located at the end of Denali Street, adjacent to the Talkeetna/Yenlo Corridor, shown on Figure 2.

Photo 14: The MEA substation located at the end of Denali Street, adjacent east of the Talkeetna/Yenlo Corridor. (August 3, 2011)

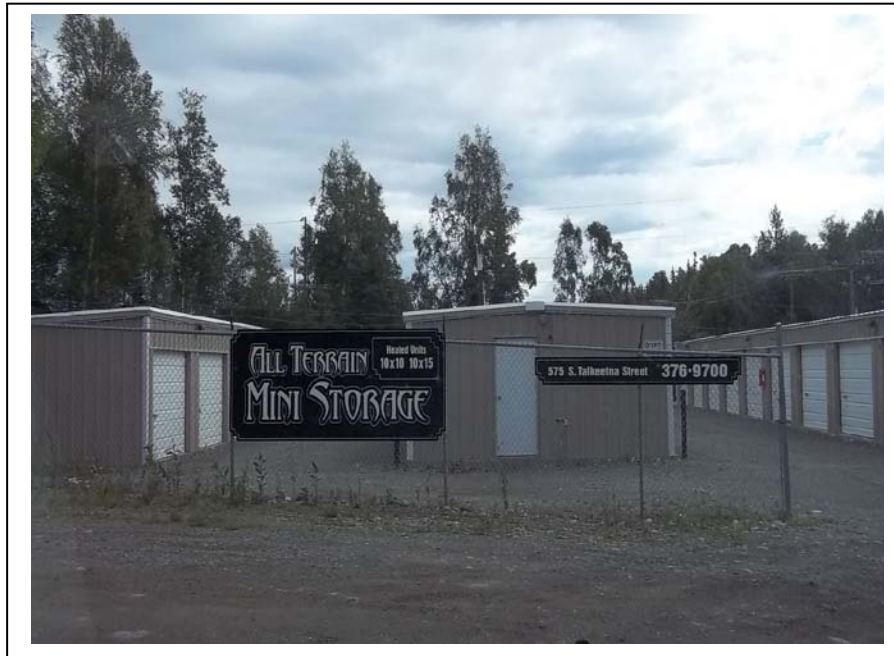
Photo 15: Mini Storage facility located adjacent east of Talkeetna Street. (August 3, 2011)

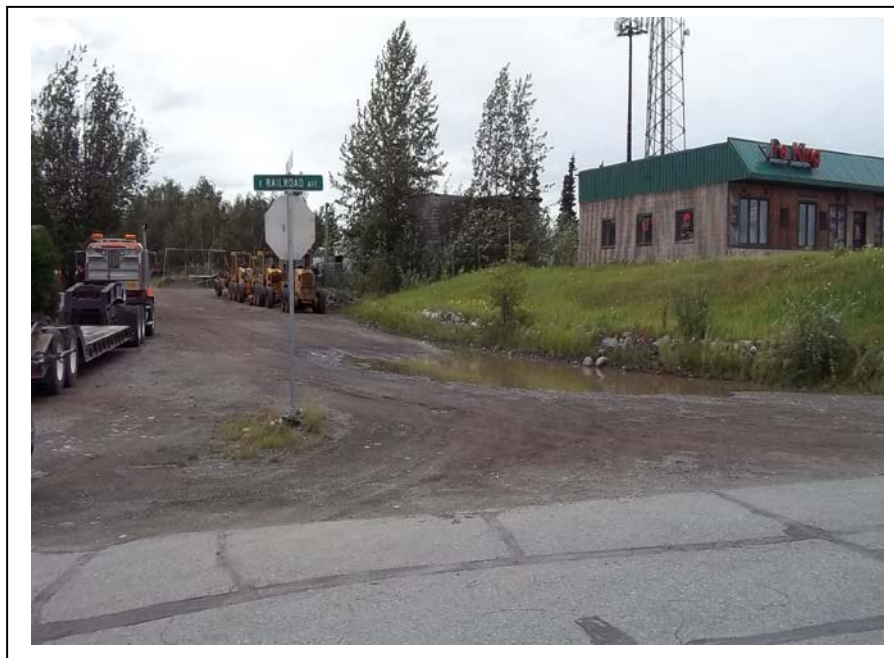
Photo 16: The intersection of Railroad Avenue and Talkeetna Street. (August 3, 2011)

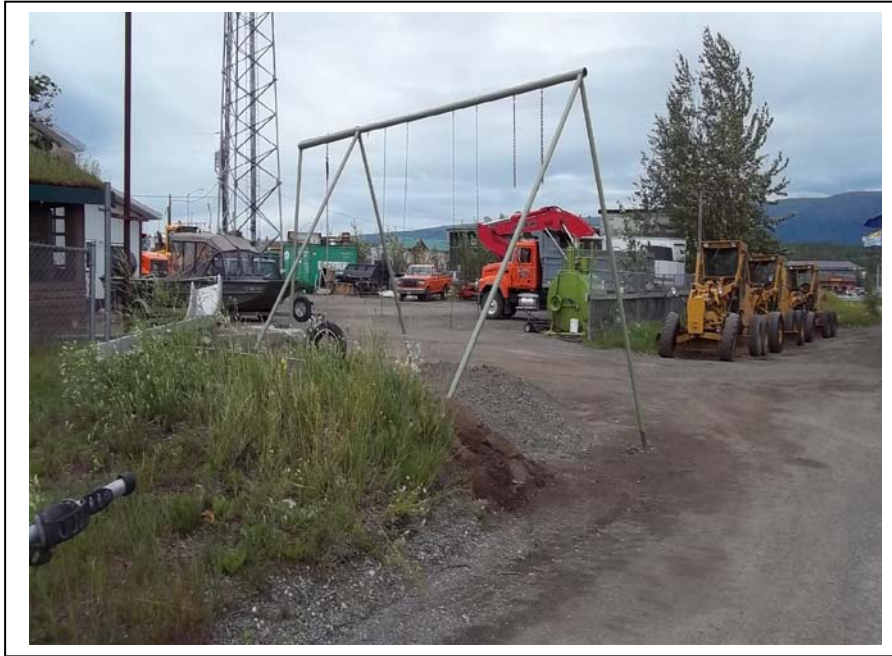
Operations at a parcel along Talkeetna Street include heavy machinery storage and an aboveground storage tank. The contents of the tank could not be identified from offsite observation. An active filling station is located adjacent to the Main Street/Parks Highway intersection. Approximate locations of these sites can be seen on Figure 2.

Photo 17: Heavy machinery and storage along Talkeetna Street. (August 3, 2011)
